BILL VIOLA STUDIO LLC.

INSTALLATION PLANS

Tumult Foundation, Torun, Poland

04/13/2025

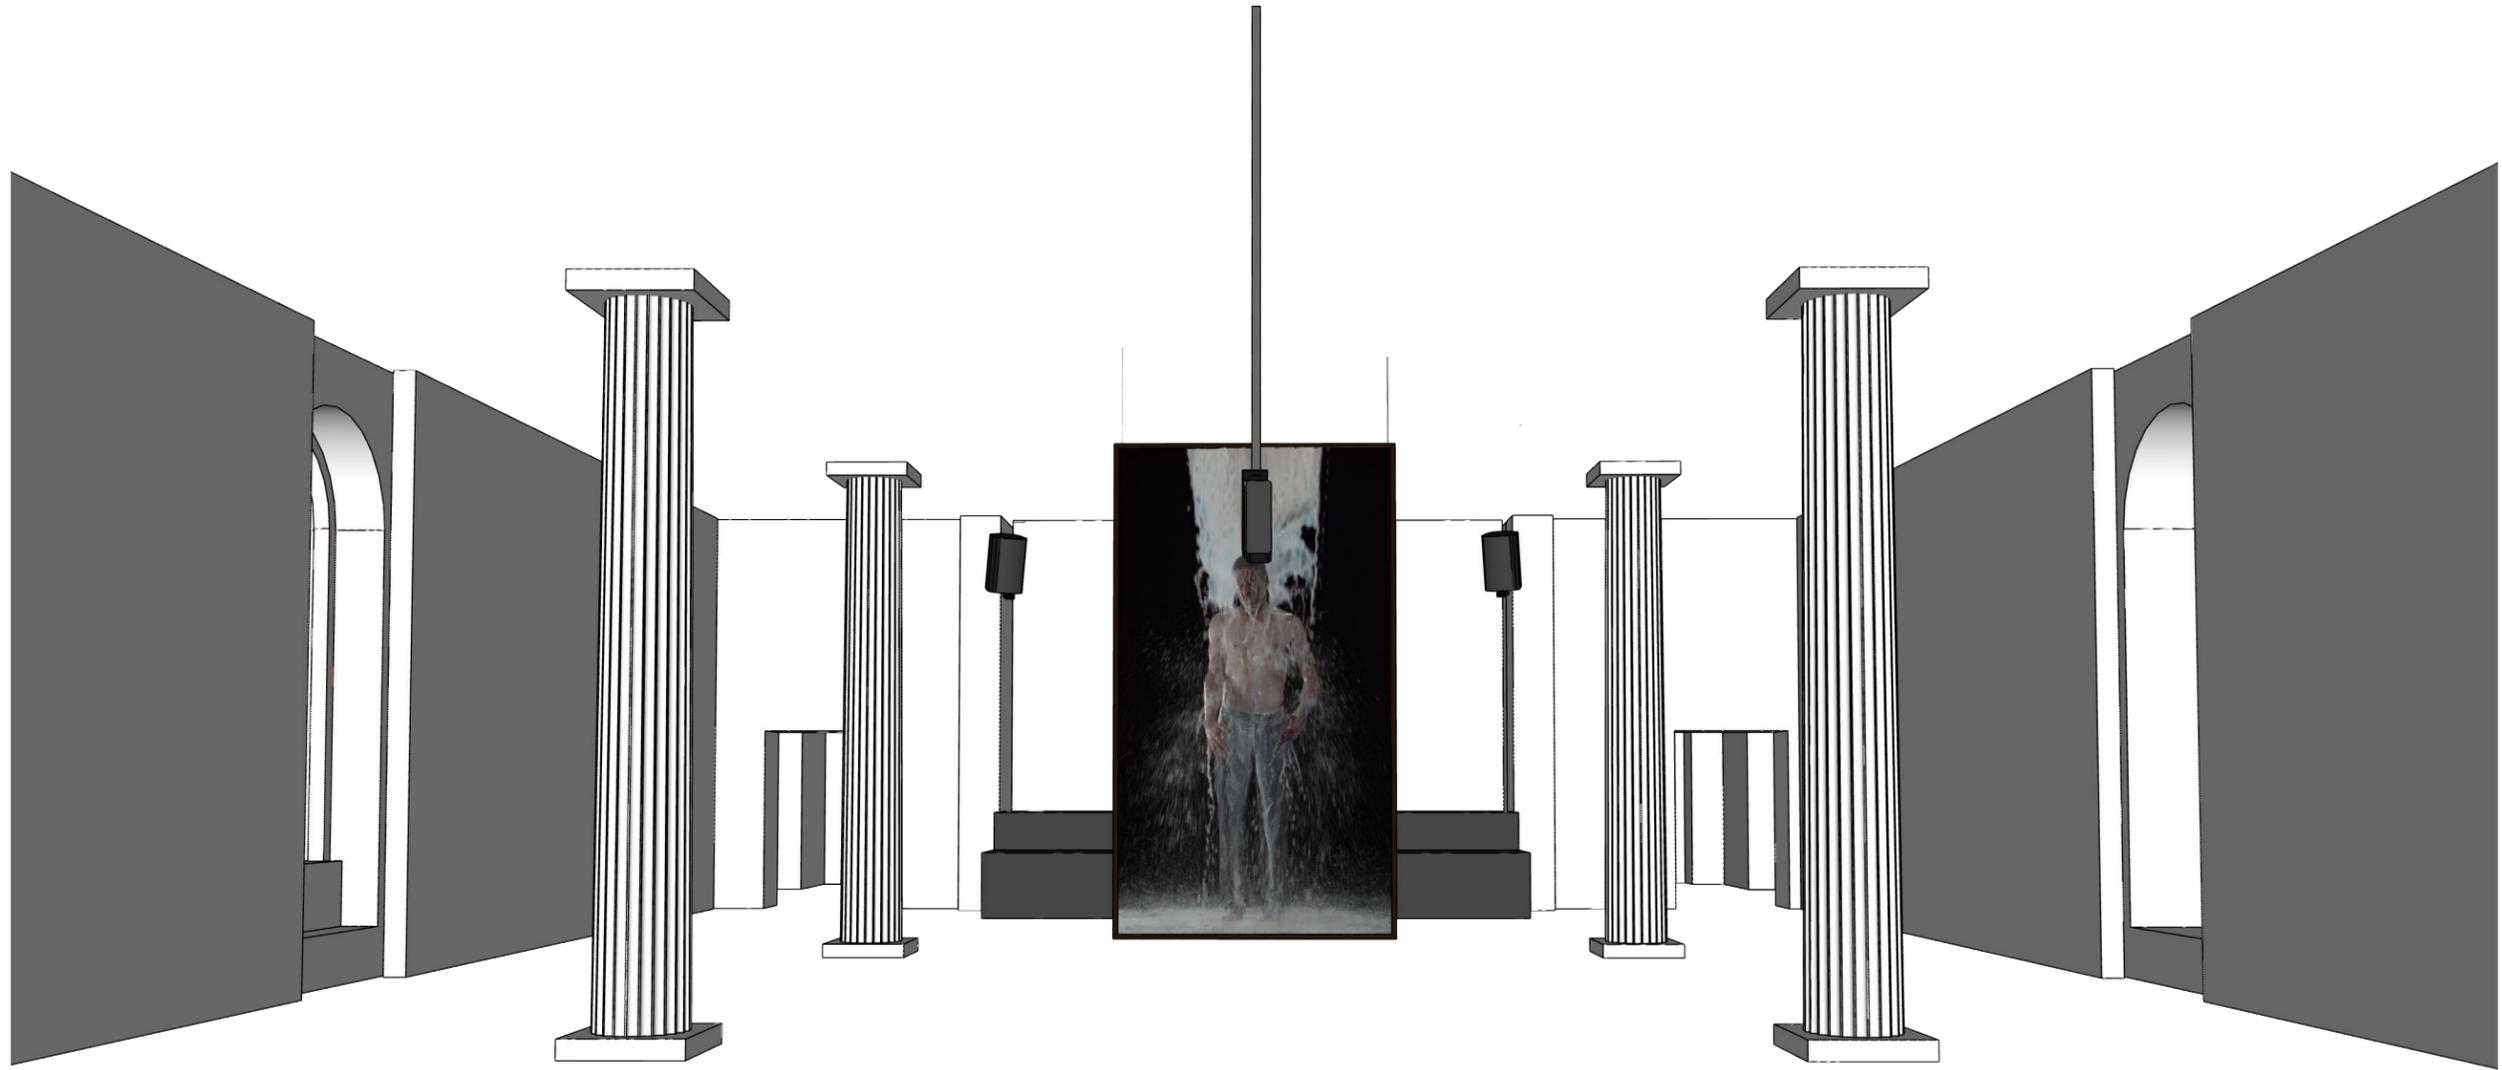
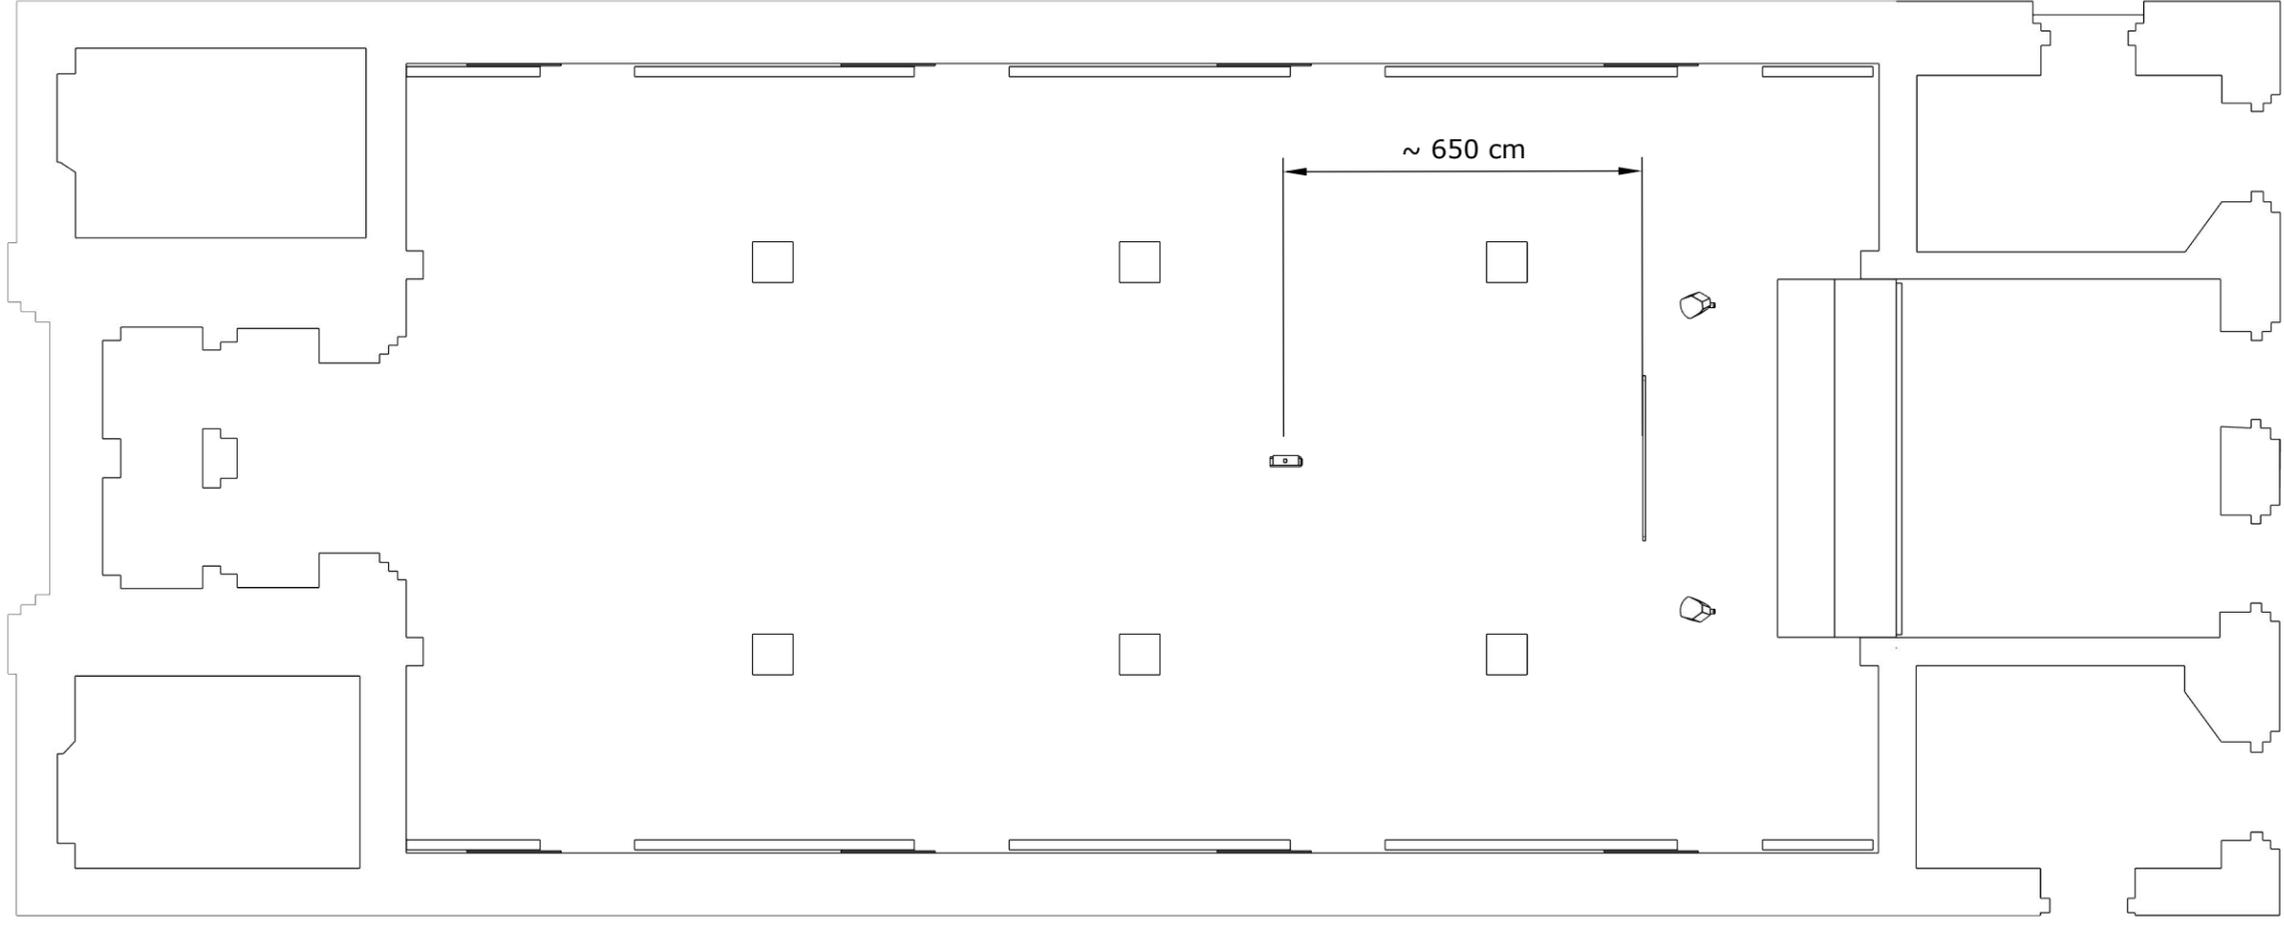
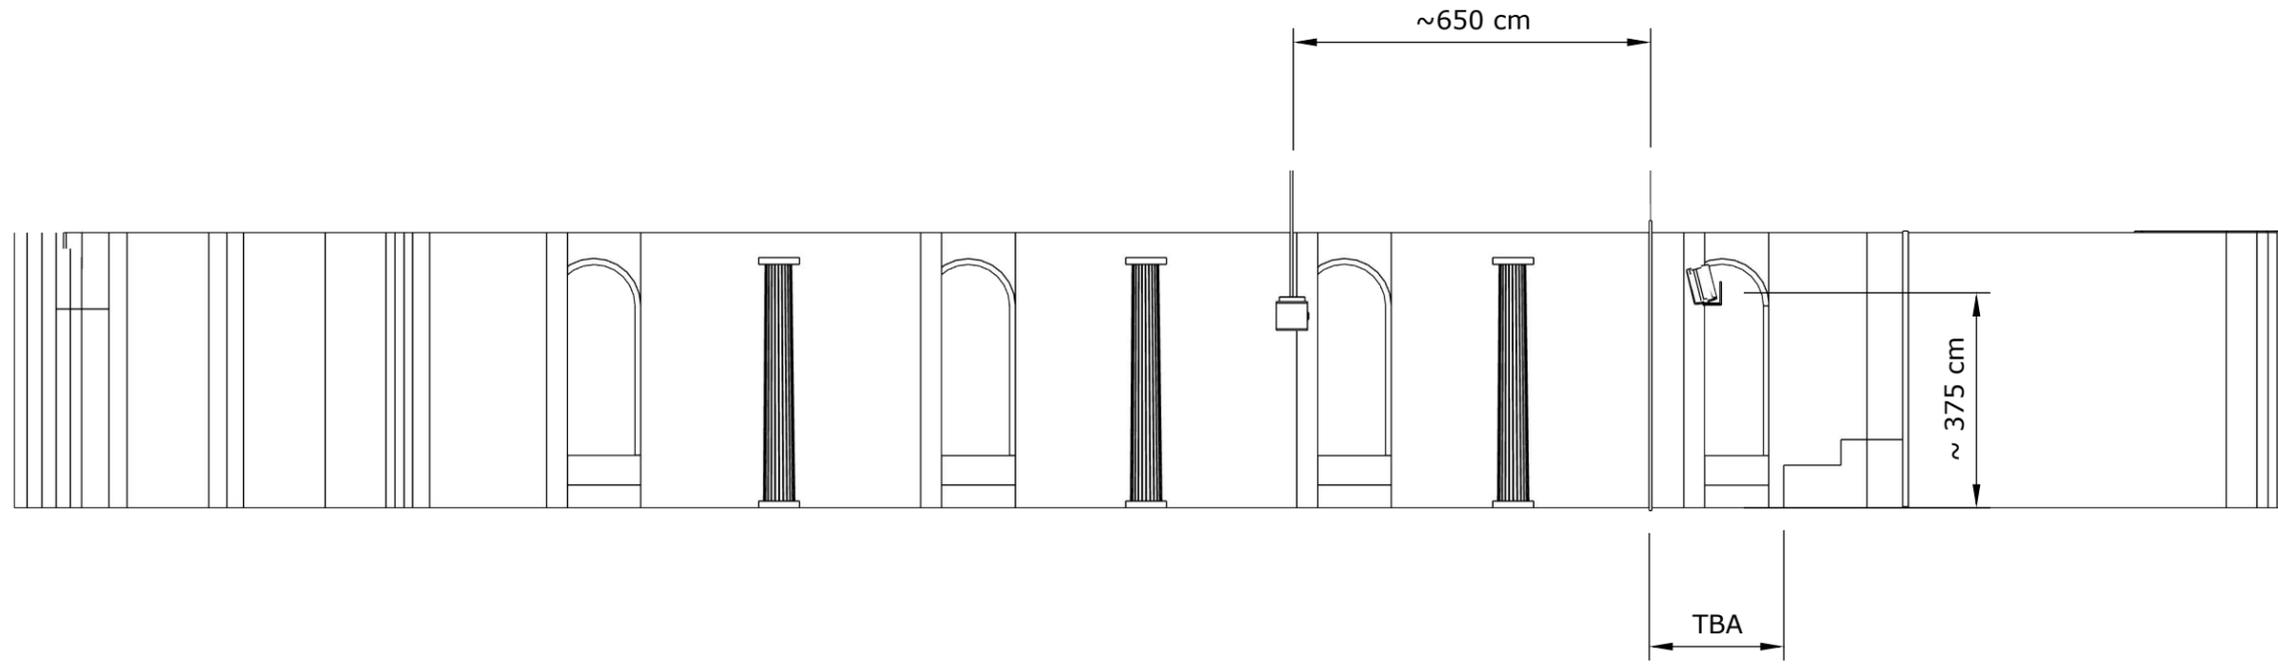
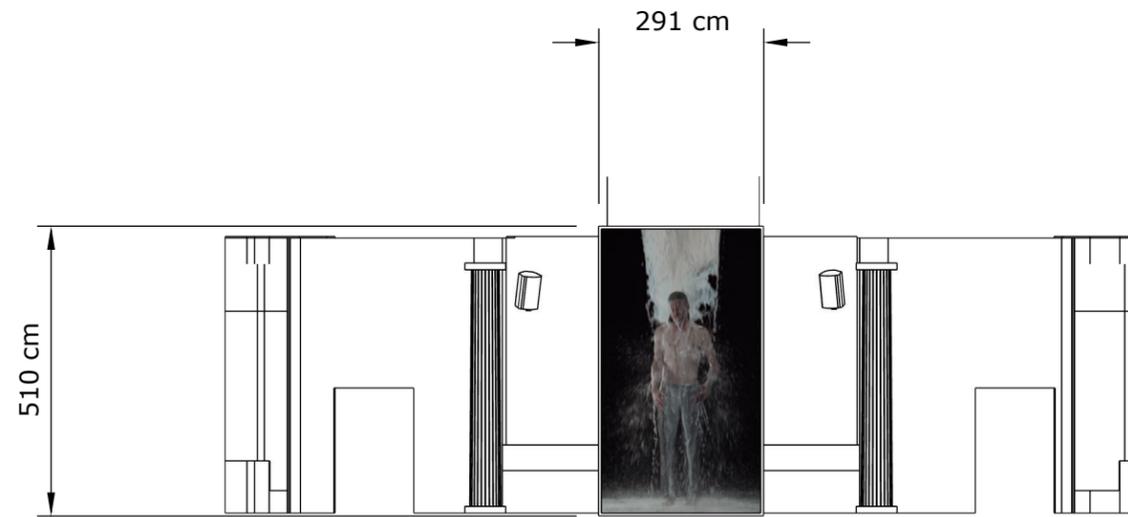
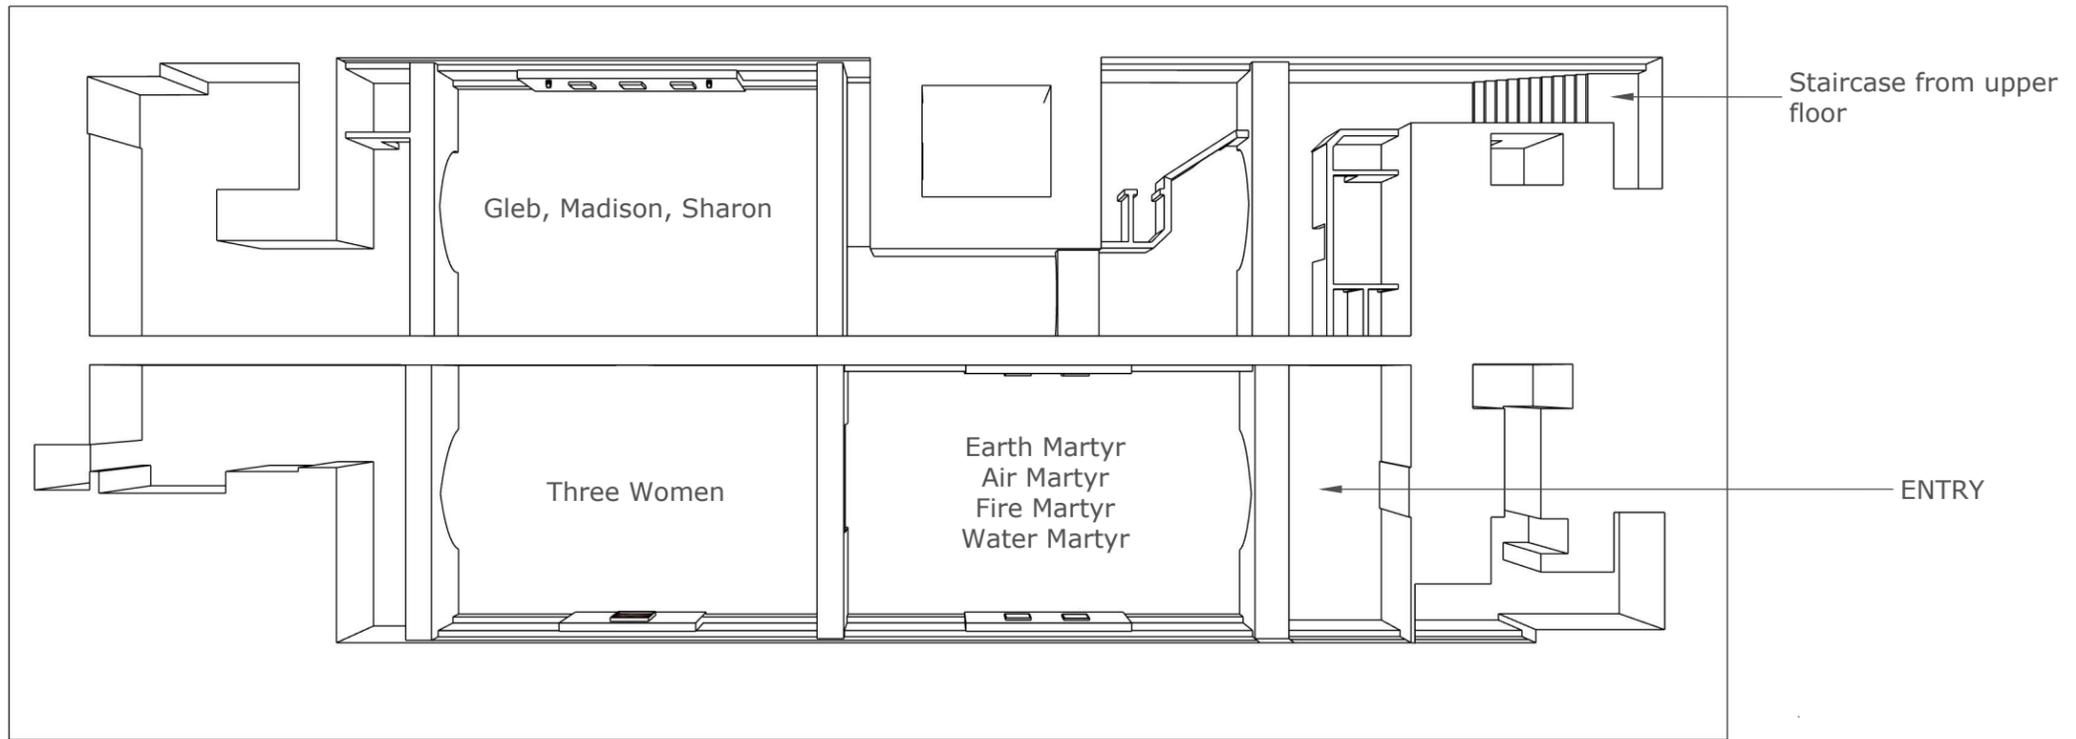
A.2

Paint Wall RAL 7043 (dark grey). Wall is open at the top, to place playback equipment atop /inside the wall construction and run all AV cables inside the wall cavity. Power (4 AMPS at 240 Volt) must be provided inside the wall cavity. The wall construction must provide enough support (gypsum with wood/ OSB backing) to mount the indicated equipment. Please confirm all details.

2 LCD Flat Screens (~ 28 kg each) wall mounted.

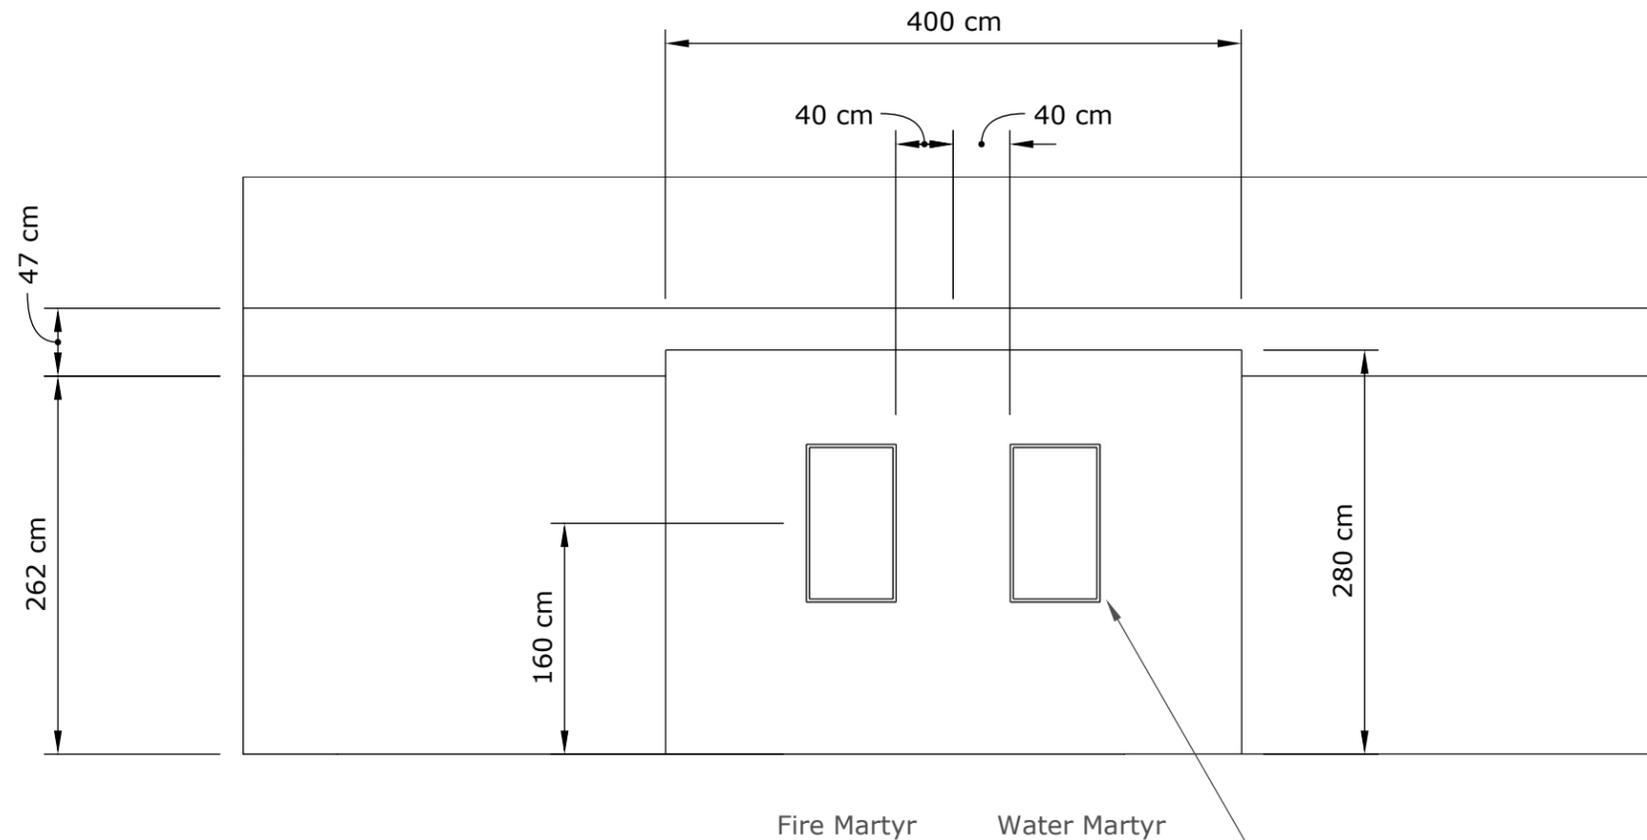
ROOM 1 WALL A

Paint Wall RAL 7043 (dark grey). Wall is open at the top, to place playback equipment atop /inside the wall construction and run all AV cables inside the wall cavity. Power (4 AMPS at 240 Volt) must be provided inside the wall cavity. The wall construction must provide enough support (gypsum with wood/ OSB backing) to mount the indicated equipment. Please confirm all details.

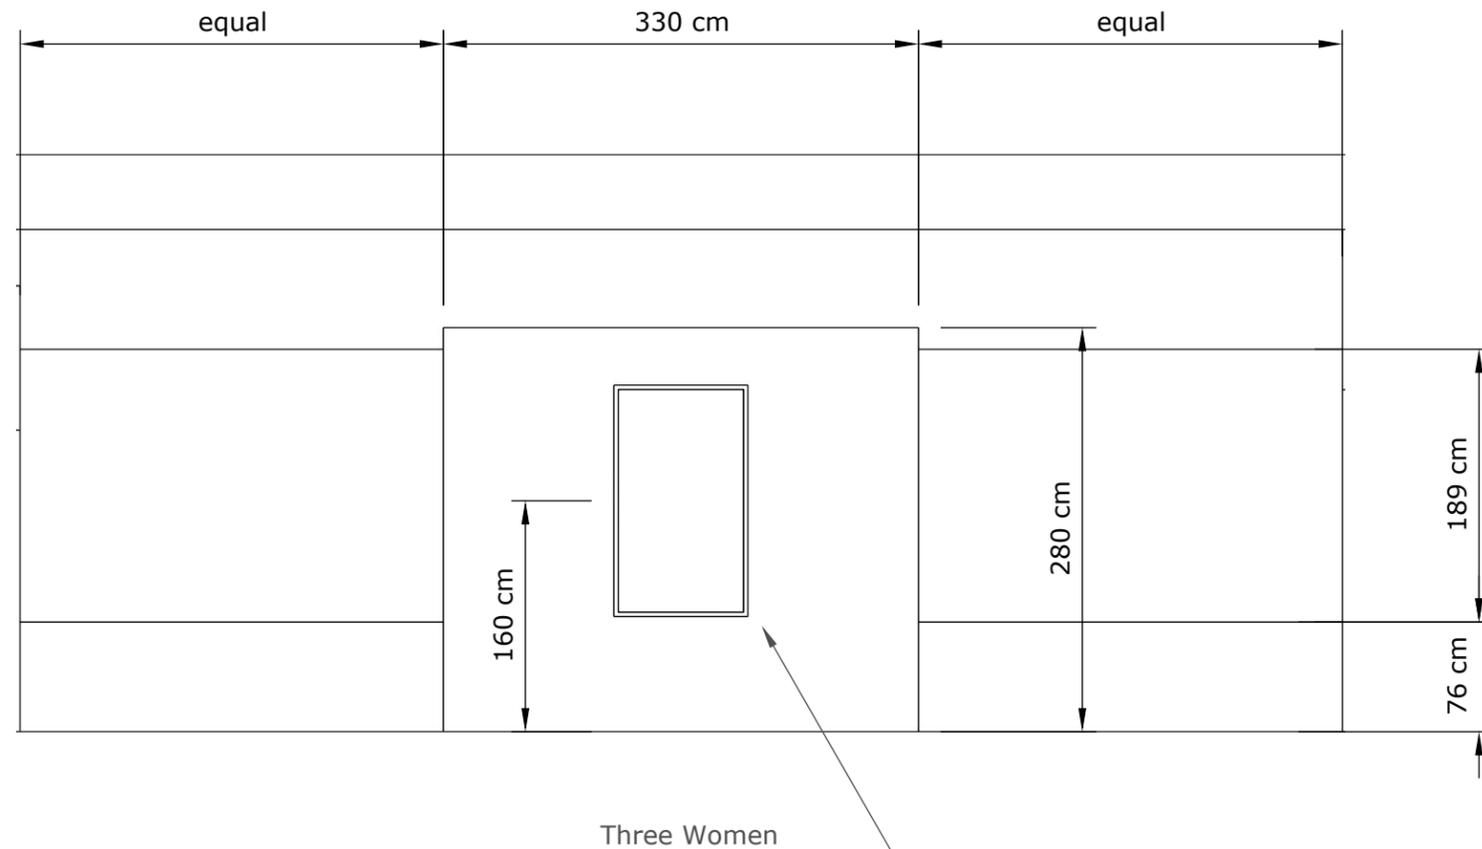
ROOM 2

Paint Wall RAL 7043 (dark grey).
Wall is open at the top, to place
playback equipment atop /inside
the wall construction and run all AV
cables inside the wall cavity.
Power (3 AMPS at 240 Volt) must
be provided inside the wall cavity.
The wall construction must provide
enough support (gypsum with
wood/ OSB backing) to mount the
indicated equipment. Please
confirm all details.
